COMPUTER SETUP INSTRUCTIONS

PANORAMIC DENTAL IMAGING

Computer & Software Setup Instructions

for a computer with Windows 10 Professional 64-bit

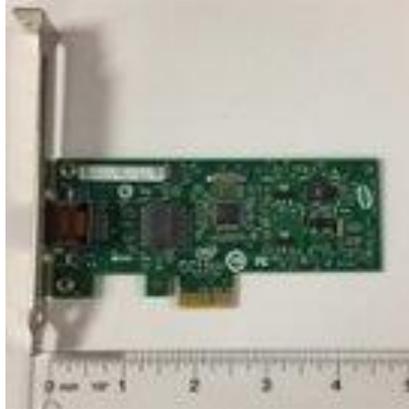
IDENTIFY CAPTURE CARD

Type	Intel CT Desktop Adaptor
Expansion Slot	PCI Express x1 or x16
Size	Full or Half Height - call to order different size bracket
Compatible Operating Systems	Windows 7 Pro 32/64 bit Windows 10 Pro 32-bit NOT SUPPORTED Windows 10 Pro 64-bit Only
Used with Pano Machines	PC-1000 Digital PC-4000 Encompass HF-100 Eagle (2D & 3D CBCT) Envision P / Envision C1

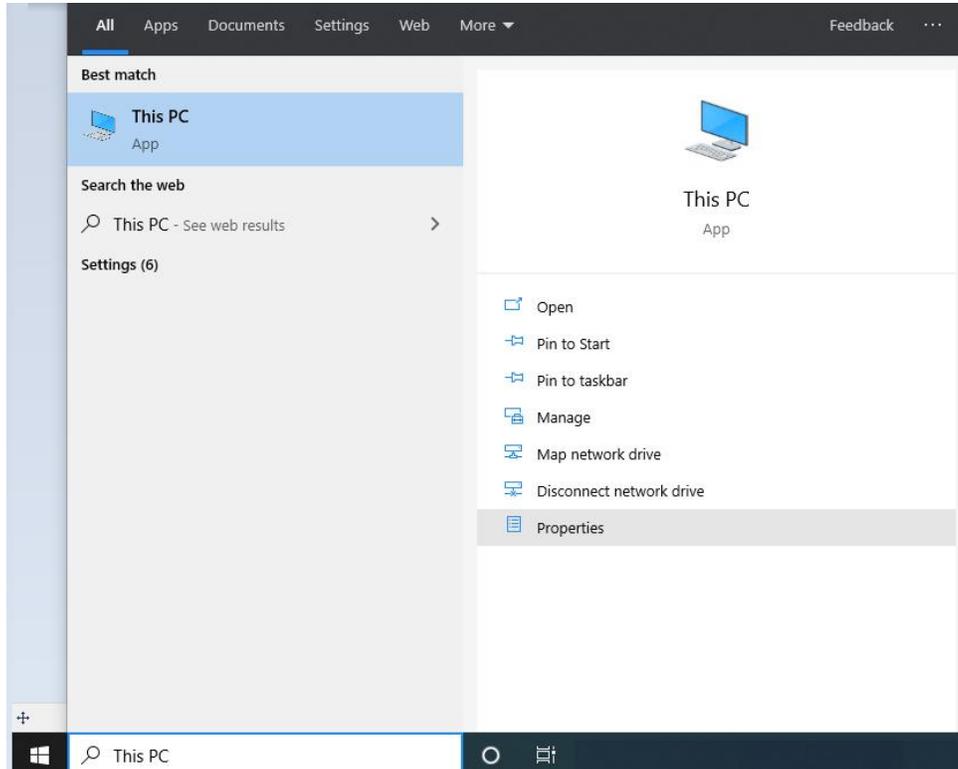
From the Start Menu, type “This PC” and click on Properties

An Example is shown. Windows 10 Professional, 64-bit Operating System

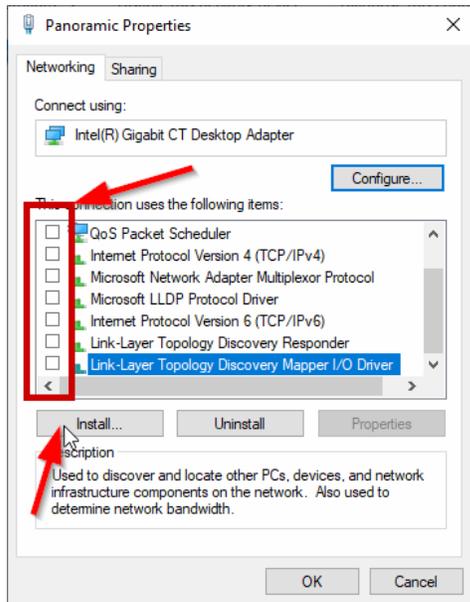
- d. Uncheck ALL items/protocols for the network adapter.
- e. Click “install” then choose “protocol” then click “add”.

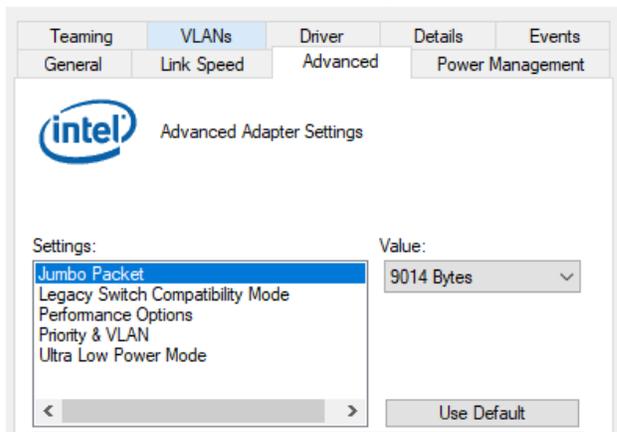
- g. Right click on the Intel CT Desktop adapter again and go into the properties, and click the “configure” button in the top right corner.

- h. Under the “Power Management” tab, uncheck all boxes.
- i. Under the “advanced” tab change “Jumbo Packet” to a value of “9014”.

- j. Change the “Receive buffers” to a value of “2048”.

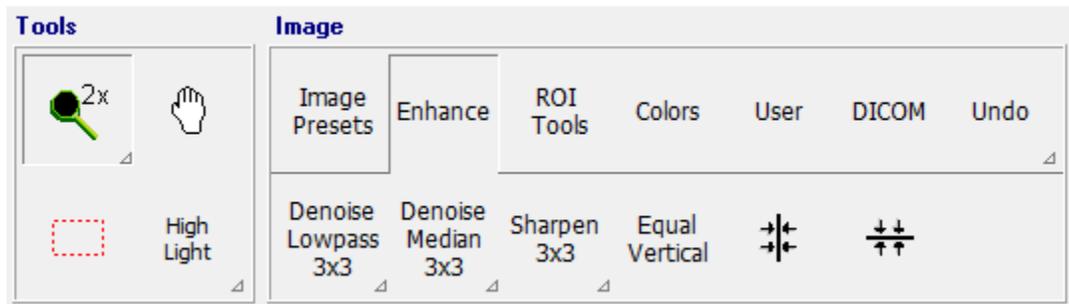
Description: The Equal Vertical tools will equalize the columns in the image. This should be the first tool used after taking a panoramic x-ray. For example, the center of the image is generally lighter because of the spinal shadow due to the position of the patient. To help minimize this “shadow” of the spine in the image, using the tool will darken the middle and lighten the sides, balancing the difference in darkness across the image.

The Equal Vertical tool is located under the Enhance button to view the buttons beneath.

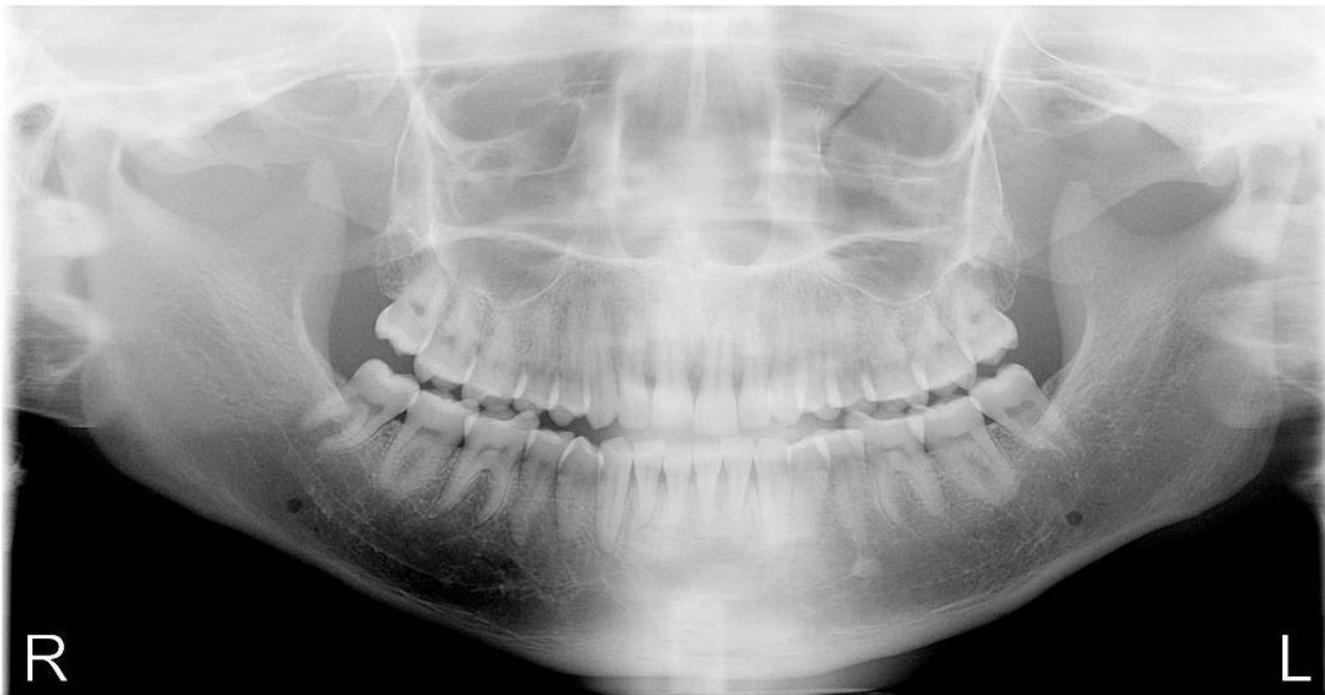
Before the Equal Vertical tool is used:

Below is an example when using the Equal Vertical tool.

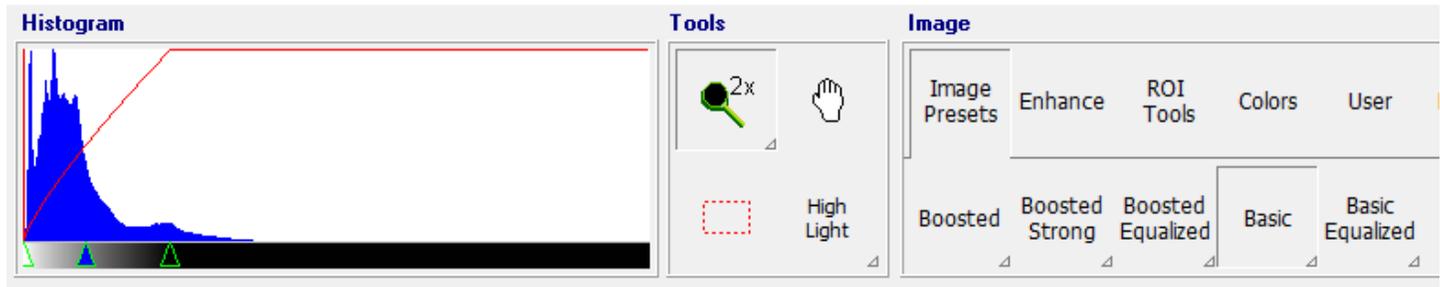
Adjusting the Histogram

After the Equal Vertical tool is used, it is best to adjust the brightness and contrast to get the best detail out of the x-ray. This is the second tool that should be used after taking a panoramic x-ray. This tool is called the Histogram.

As seen in the examples above, there are three small green triangles at the bottom of the tool. Moving these triangles side-to-side will adjust the brightness and contrast values of the image. To move the triangles simply left-click the triangle using the mouse and drag them side to side. When the triangle is in its desired position, release the left-mouse button. Be careful not to overlap the triangles when adjusting them, otherwise the software will not know which triangle to move. To best learn this tool, adjust the triangles and notice the difference in the image after the adjustment. Utilizing this tool can greatly improve the quality of the x-rays.

The farthest right triangle, usually seen as green outline with black in the center, controls the contrast or darkness (dark levels) of the image. The default position for this triangle is against the far right side. This should be the first triangle to be moved.

The middle triangle, usually seen as the green outline with blue center, controls the brightness of the image. The default position for this triangle is right in the center. This is the second triangle to be moved.

The farthest left triangle, usually seen as green outline with white center, controls the whiteness (white levels) of the image. The default position for this triangle is against the far left side. This triangle should normally be ignored and kept in its default position.

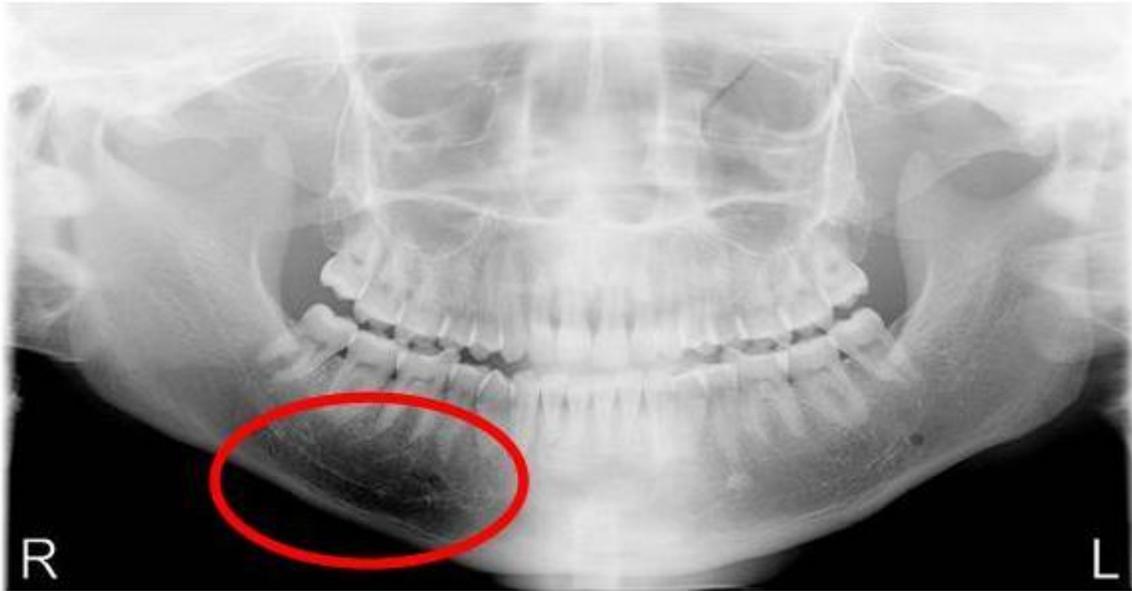
As an example on how to use this Histogram tool, adjust the contrast (most right) triangle from right to left until you start to see “burn out” in the jawbone or skeletal figure. (See below)

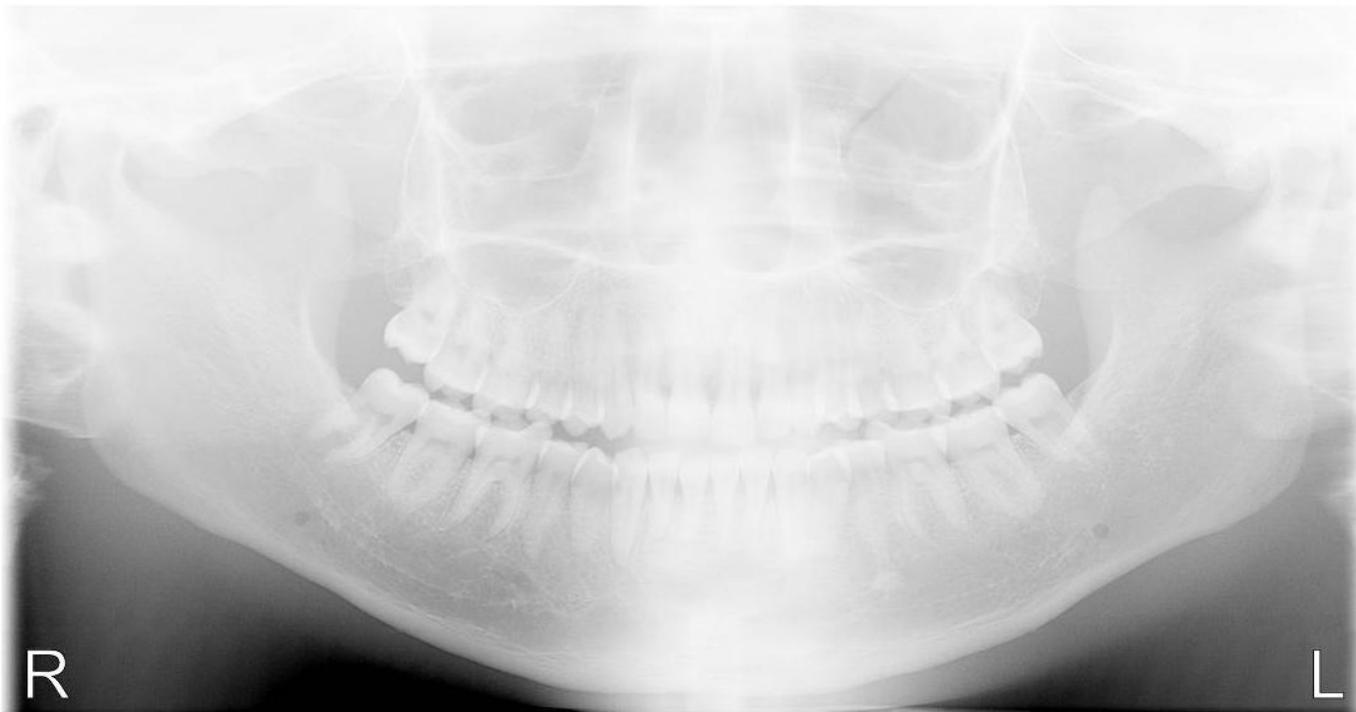
Before the Histogram tool is used:

Below is an example when using the Histogram (or Image controls) tool.

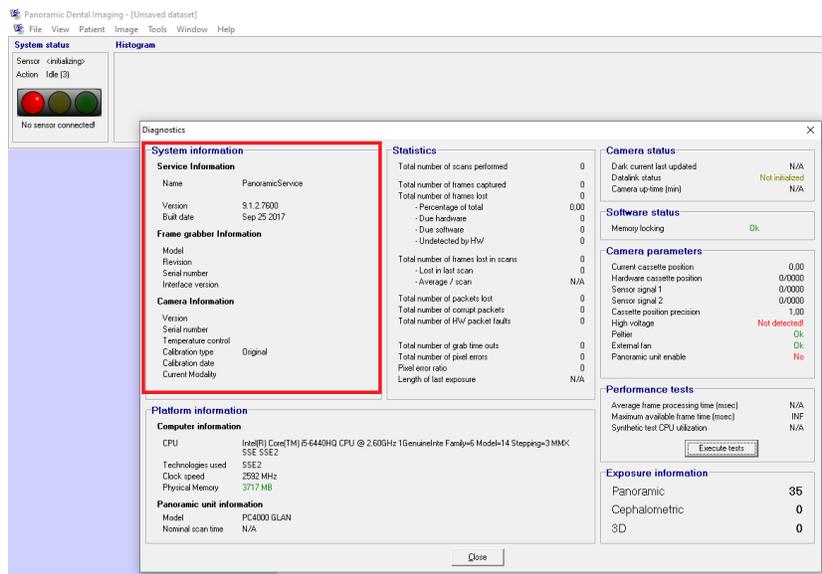
The diagnostics screen shows (below in red) the software version 9.1.2.7600

The Frame grabber Information is blank. This is where the INTEL CT DESKTOP ADAPTER should be listed.

This tells us the software is not connected to the interface card.

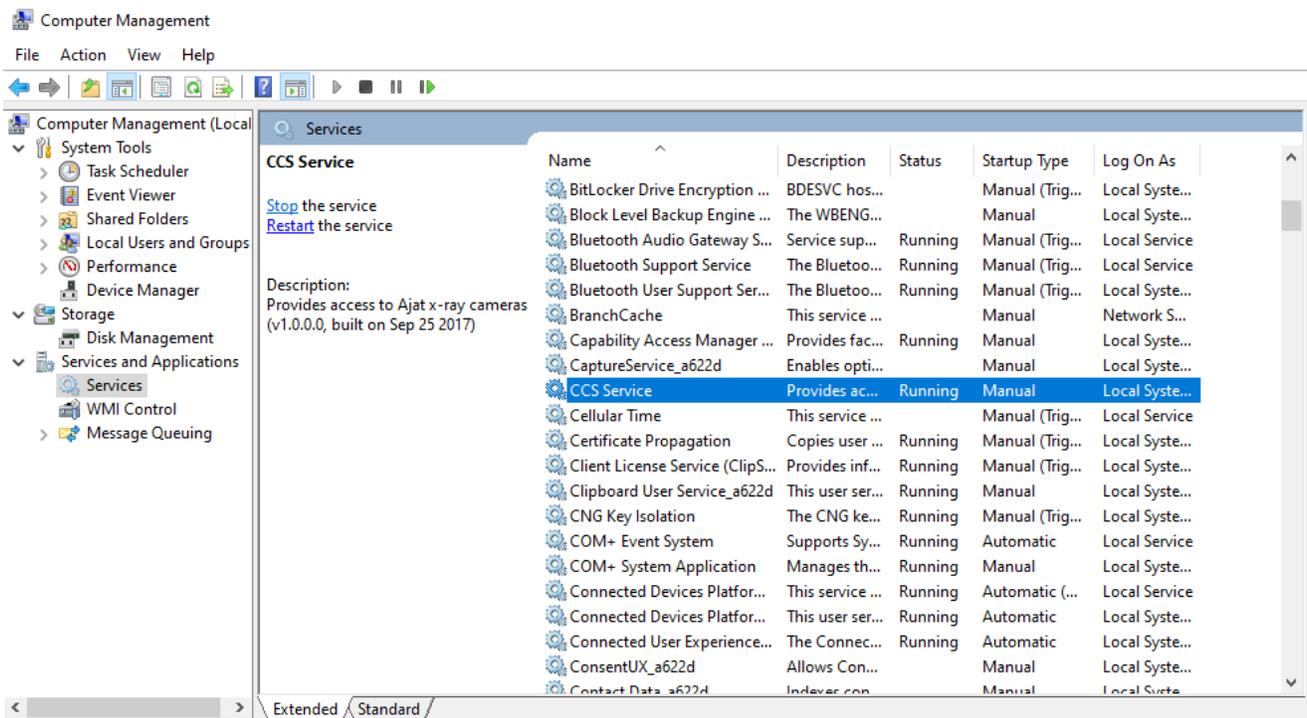
Under the Services and Applications category, expand and then click on Services (left). The list of system processes are listed on the right. Find 'CCS Service' in the list, highlight, and then click on the 'Restart' link to the top left.

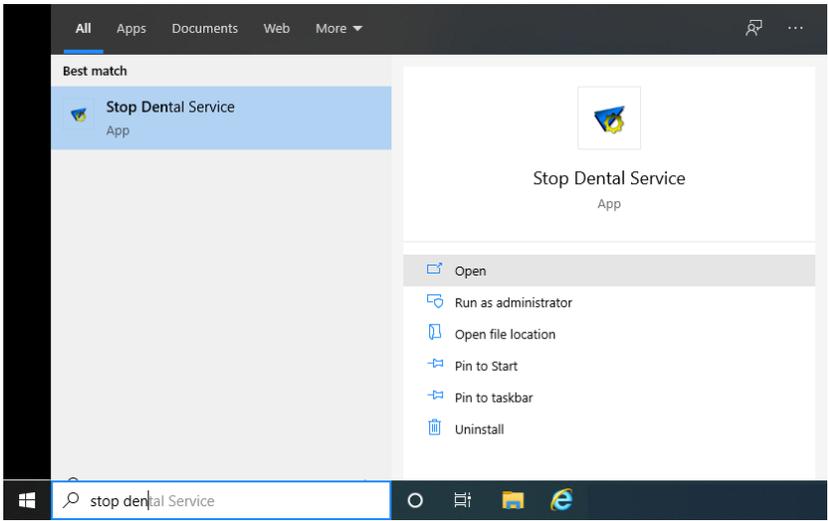
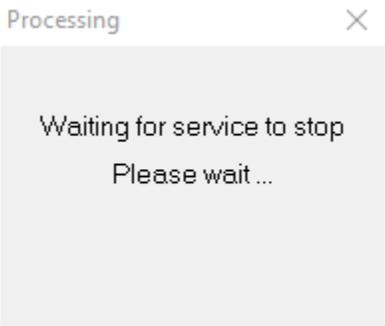
Open the Stop Dental Service program/command first.

Afterwards you’ll see a small box show a message “waiting for service to stop”

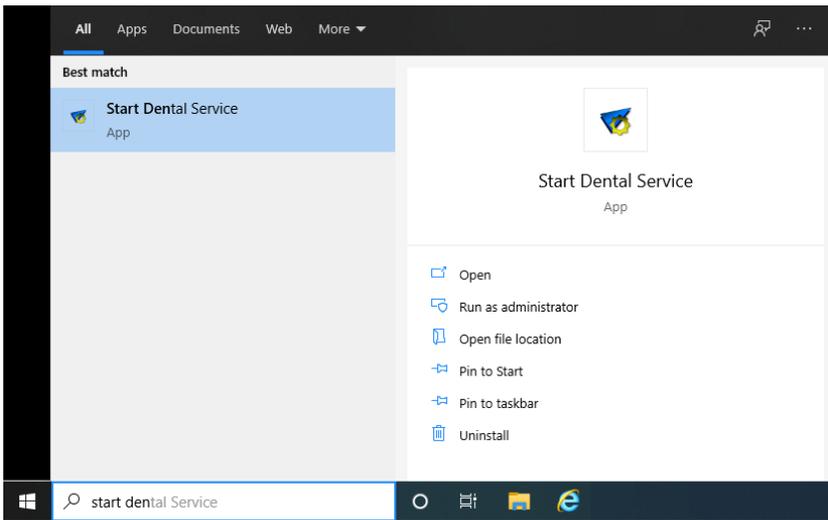
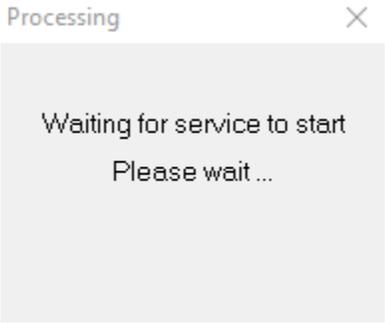
After the small box has disappeared, you can then Open the Start Dental Service program/command.

Again you will see a small box show a message “waiting for service to start”

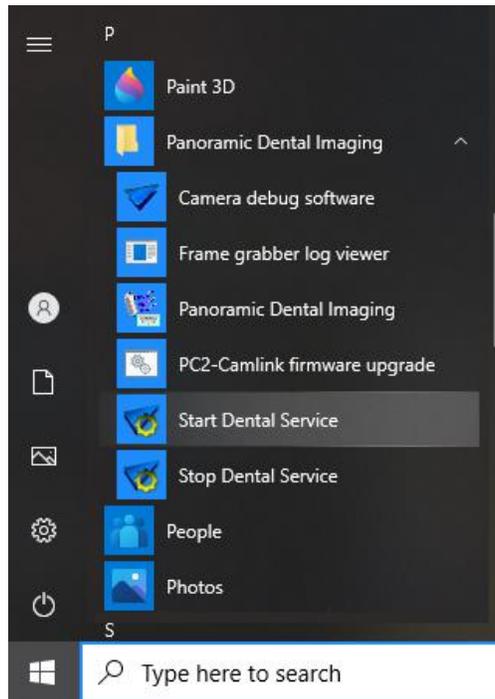
These commands are also listed under the Start Menu > Panoramic Dental Imaging >

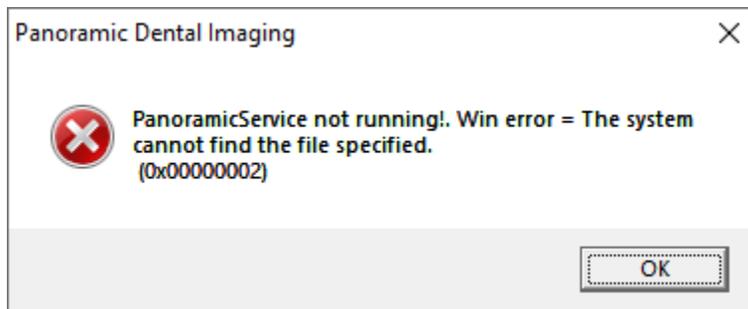
Note: If the Panoramic Dental Software is opened when the background service is NOT running, an error message will appear as below. To correct this, start the background service as described above, and then the program can be opened.

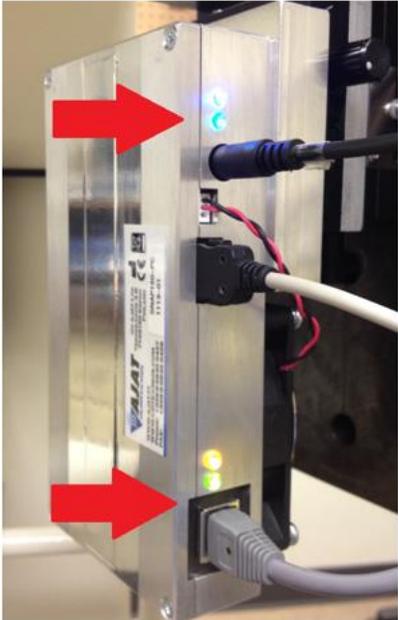
If desired, take off the plastic covers around the digital sensor. Four hex screws, size 3/16 standard, 2 on both sides.

Check to see if the Sensor has a power light (right side, top)

Check to see if the Ethernet datacable has a connection (right side bottom)

Carefully place the front and rear sensor covers over the counter weight and sensor. Align the mounting holes to the side holes on the counter weight plate.

Press from the bottom of the front plastic cover to assure the covers are shifted UP as high as possible providing the maximum shoulder clearance.

Install the four (4) allen screws to attach the covers.

Do not over-tighten the screws because it can cause damage to the plastic covers

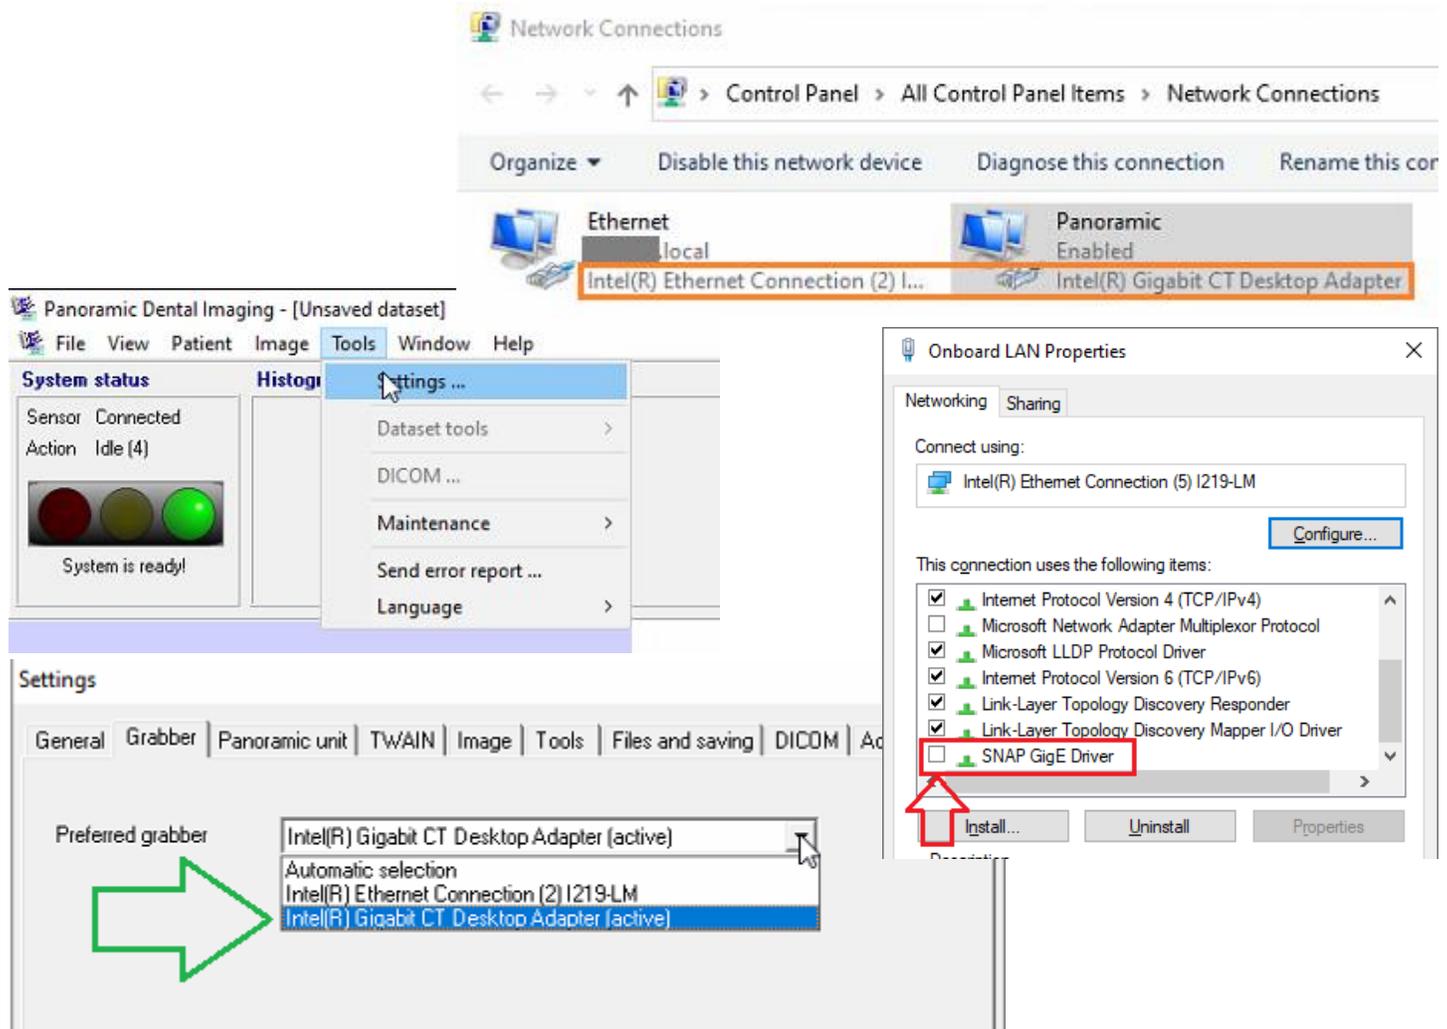
If the computer has two INTEL brand NICs, then ensure the software is pointing/using the correct interface. If the computer does not have two Intel NICs, then continue onto the next page.

1. With the background service stopped, go to the properties of the NIC that is **NOT used for the Pano**, and uncheck the SNAP GigE protocol. Ensure the SNAP GigE protocol is enabled on the Pano NIC. Then start the background service as described earlier on page 2 (CCS Service)
2. Within the Panoramic Dental Software, under the **Tools** menu, choose **Settings**. (screenshots below for reference)
3. Under the **Grabber** tab, ensure the Correct Intel device is selected. Restart the computer if desired to check the software status.

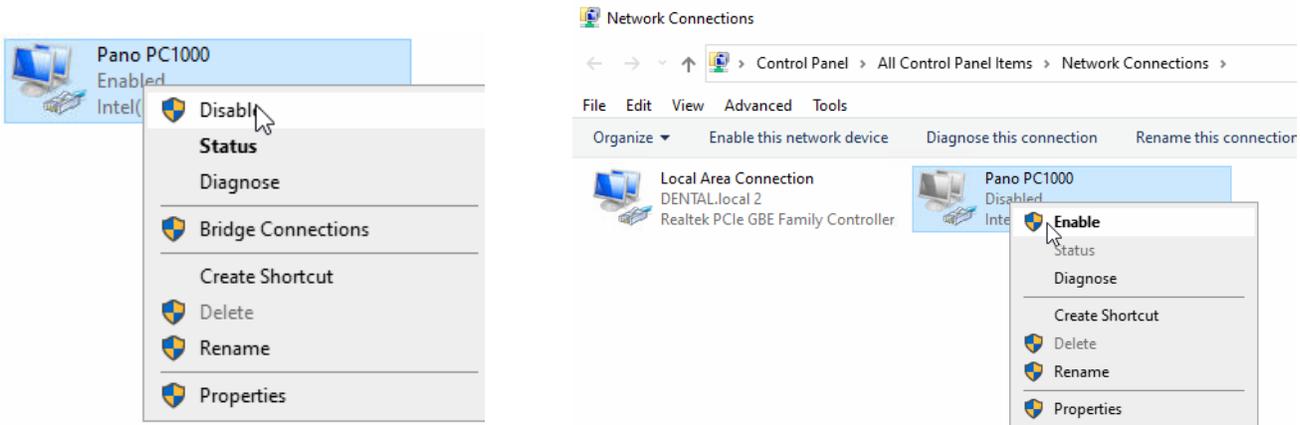
If no changes were needed, then **Disable** the NIC and then **Enable**. This can be done through the right-click shortcut menu on either network connections or the Computer Management / Device manager window (shown above on pg 2).

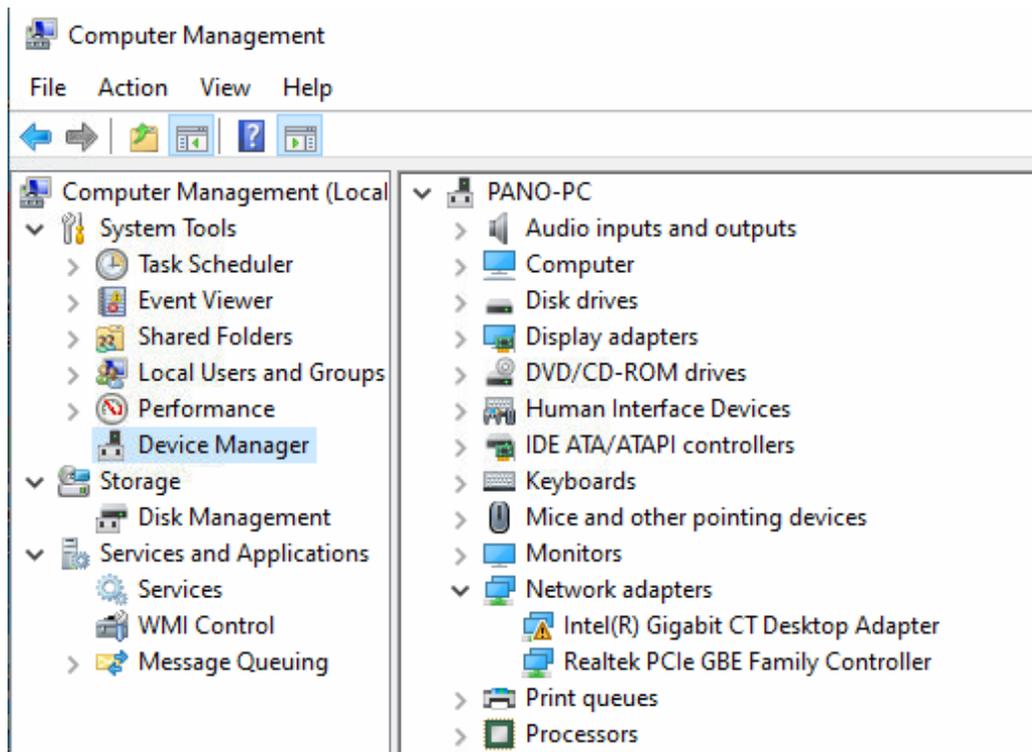
After the command to **Enable** the NIC, check the device manager to see if the NIC is **flagged** for having a problem.

If the NIC disappears from the Network Connections window, then it should be found **flagged** in the device manager.

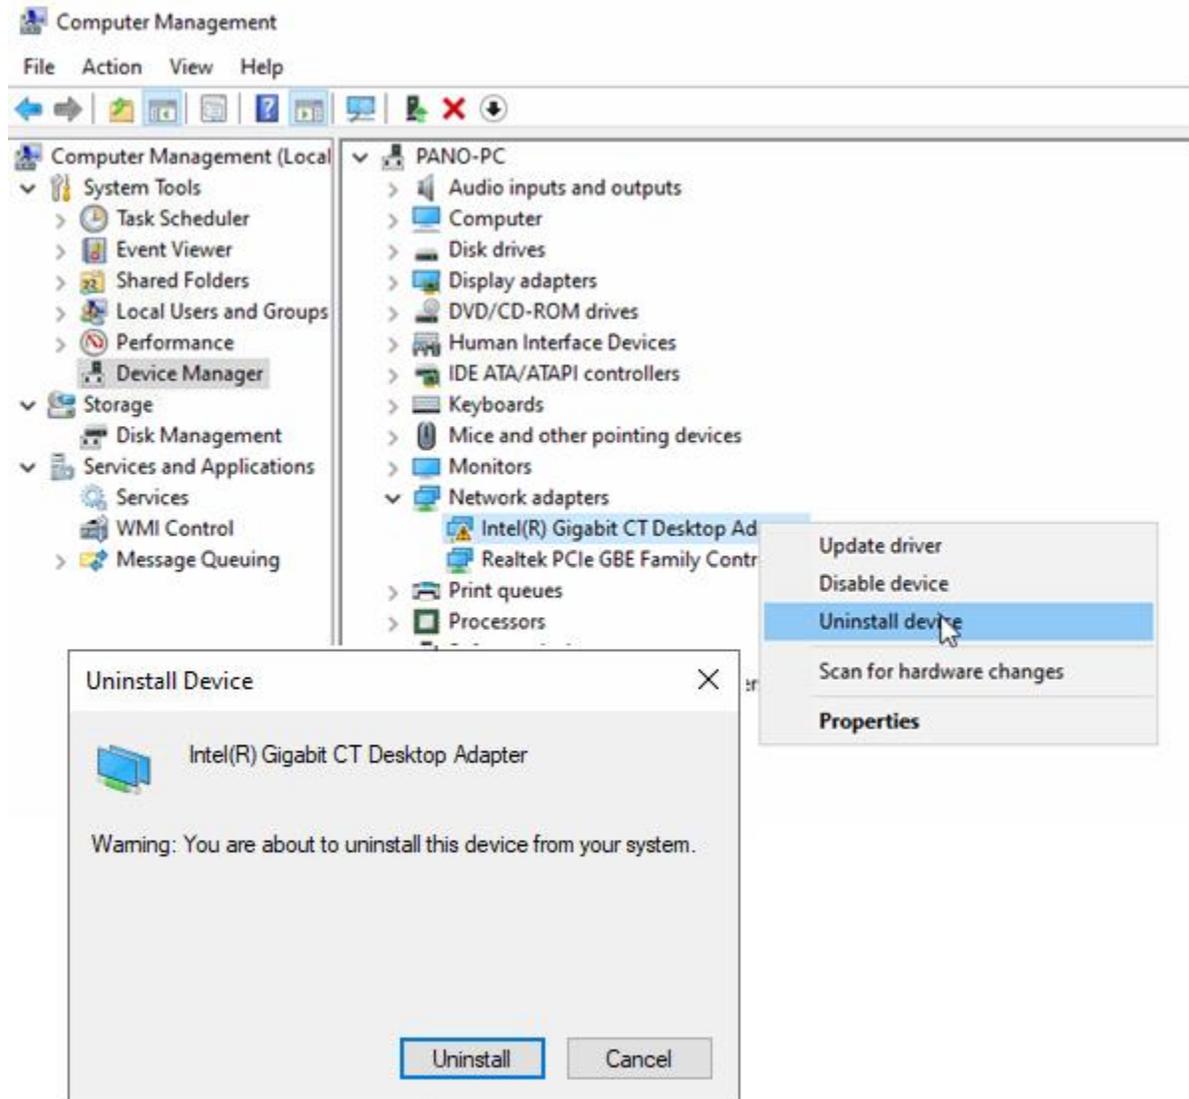
If found **flagged**, right-click the grabber and **Uninstall device**. A reboot of the computer is required for the Windows Operating System to reinstall this device. After a computer reboot stop the background service, and reconfigure the NIC according to the installation guide above, pages 7-9. Then stop/start the background service and check the software status.

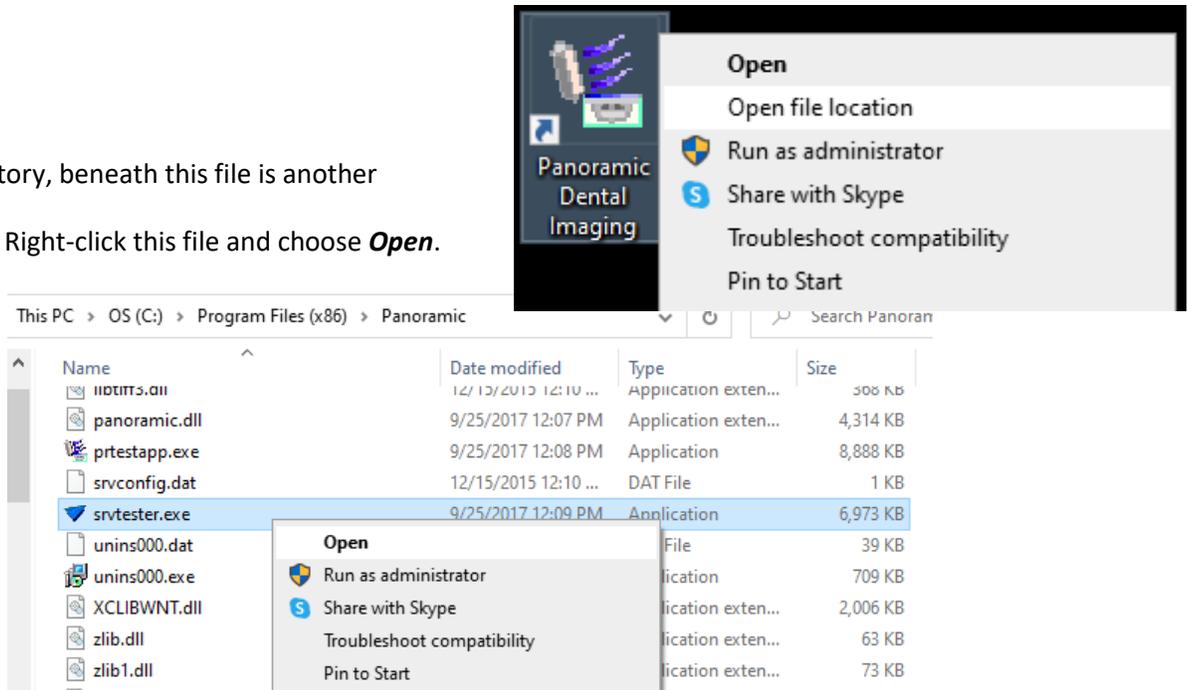
Then Right-click the desktop icon and choose **Open file location**.

In the Program directory, beneath this file is another called srvtester.exe. Right-click this file and choose **Open**.

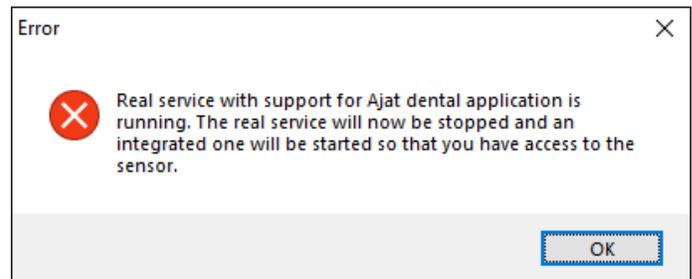
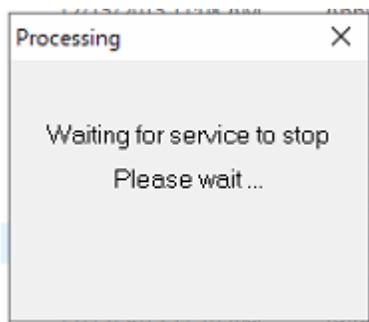
An Error message will appear. This is only a warning/information message. It is not truly an error. Click OK.

Be patient as the software will stop/start some background processes. This takes roughly 5 seconds depending on computer specifications / performance.

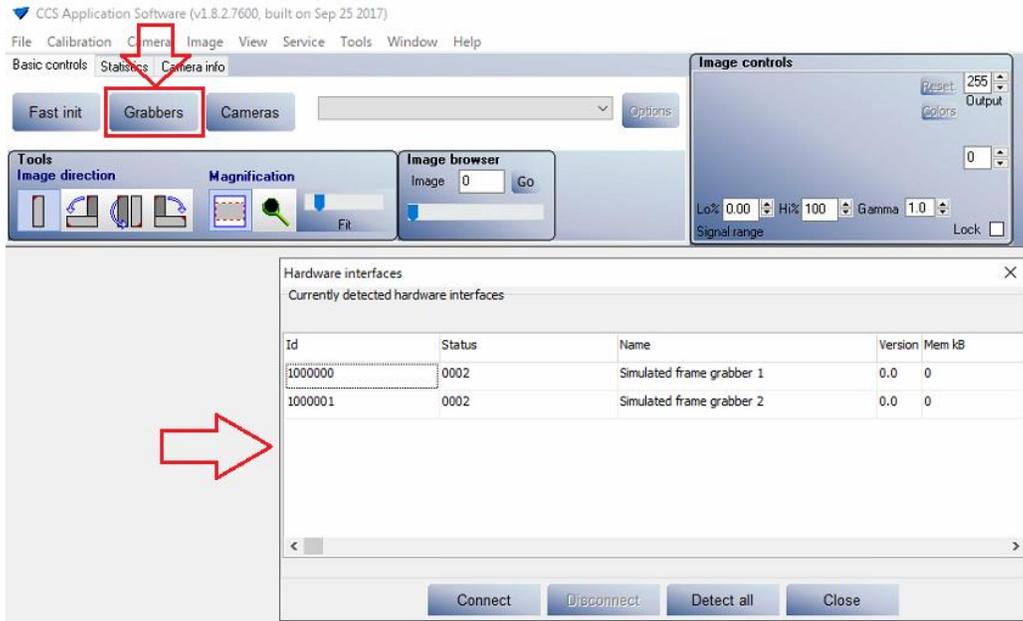
Once the application opens, click the **Grabbers** button in the TOP LEFT.

Choose the Intel grabber and click **Connect**.

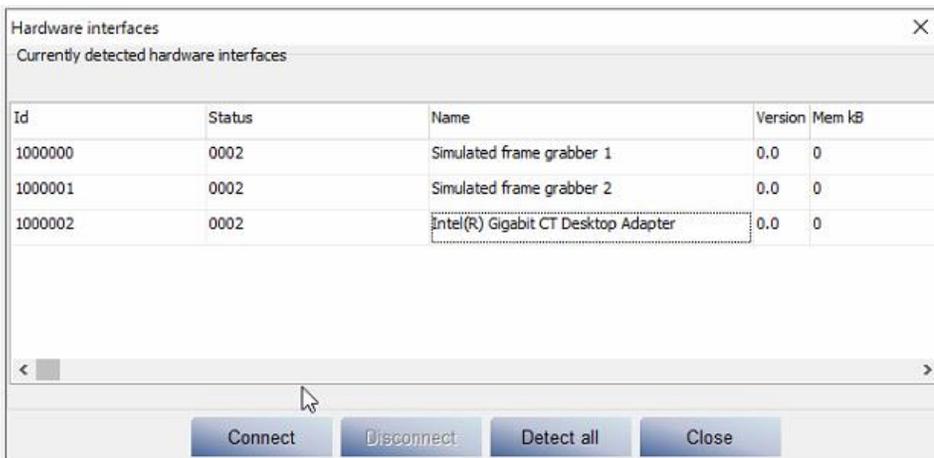
BE PATIENT!!! The software will want to Start/Stop the background process as you exit & reopen the program.

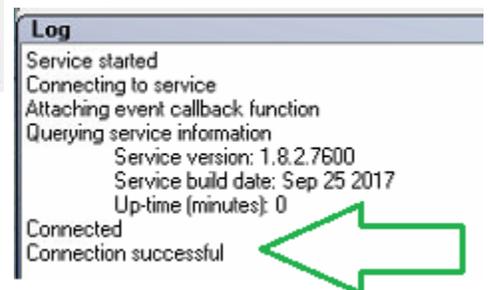
There is a real-time log of the event in the bottom left of the screen showing a connection was successful. If there are error codes, it would suggest a problem with the card, or may need to be physically reinserted into the PC.

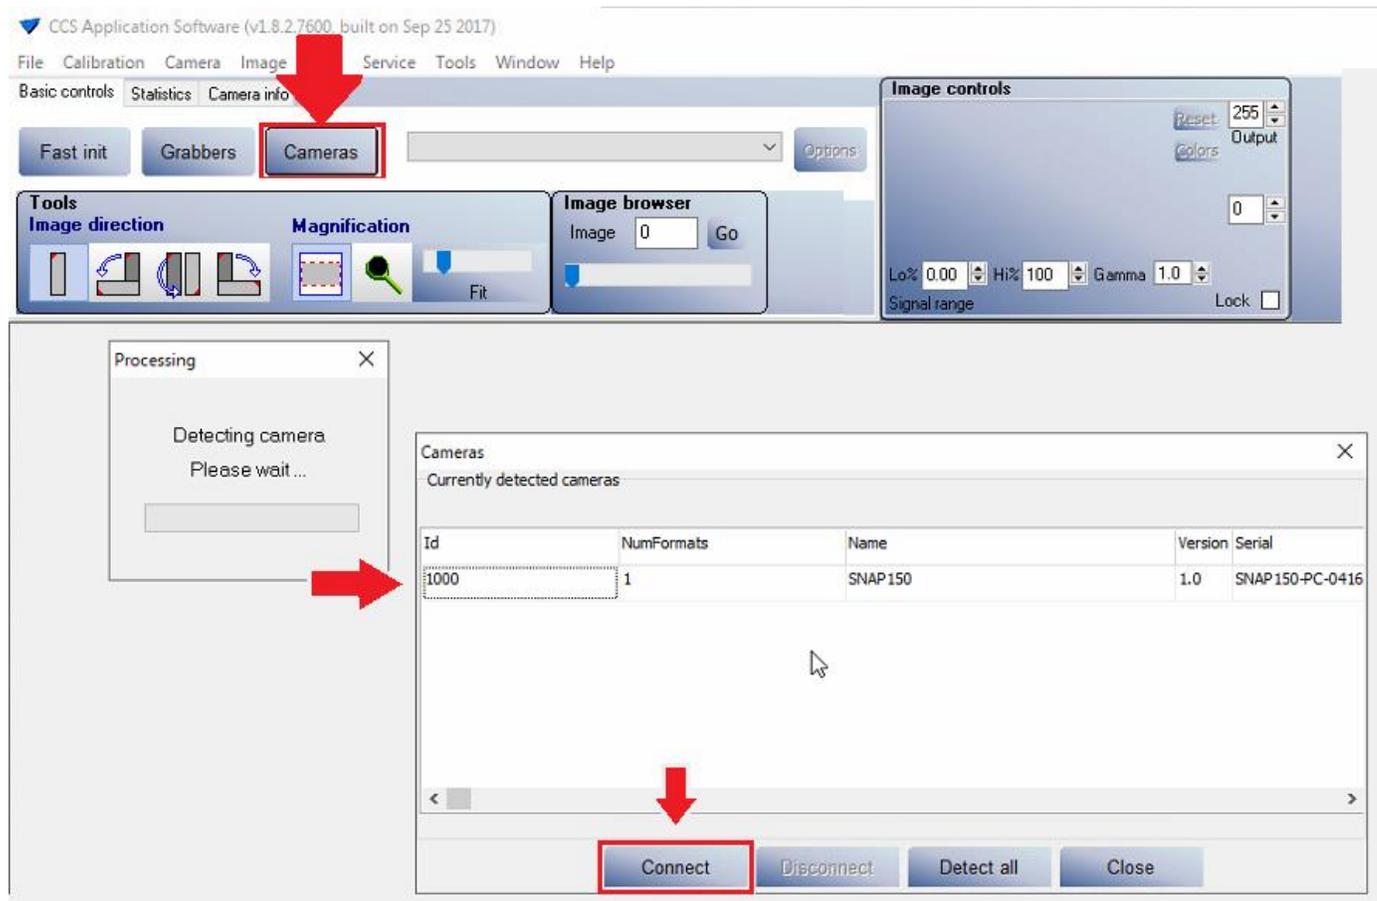
Next click the **Cameras** button in the TOP LEFT.

The software will take a brief moment to Detect the camera, and then display the list.

Click on the sensor shown, and click the **Connect** button.

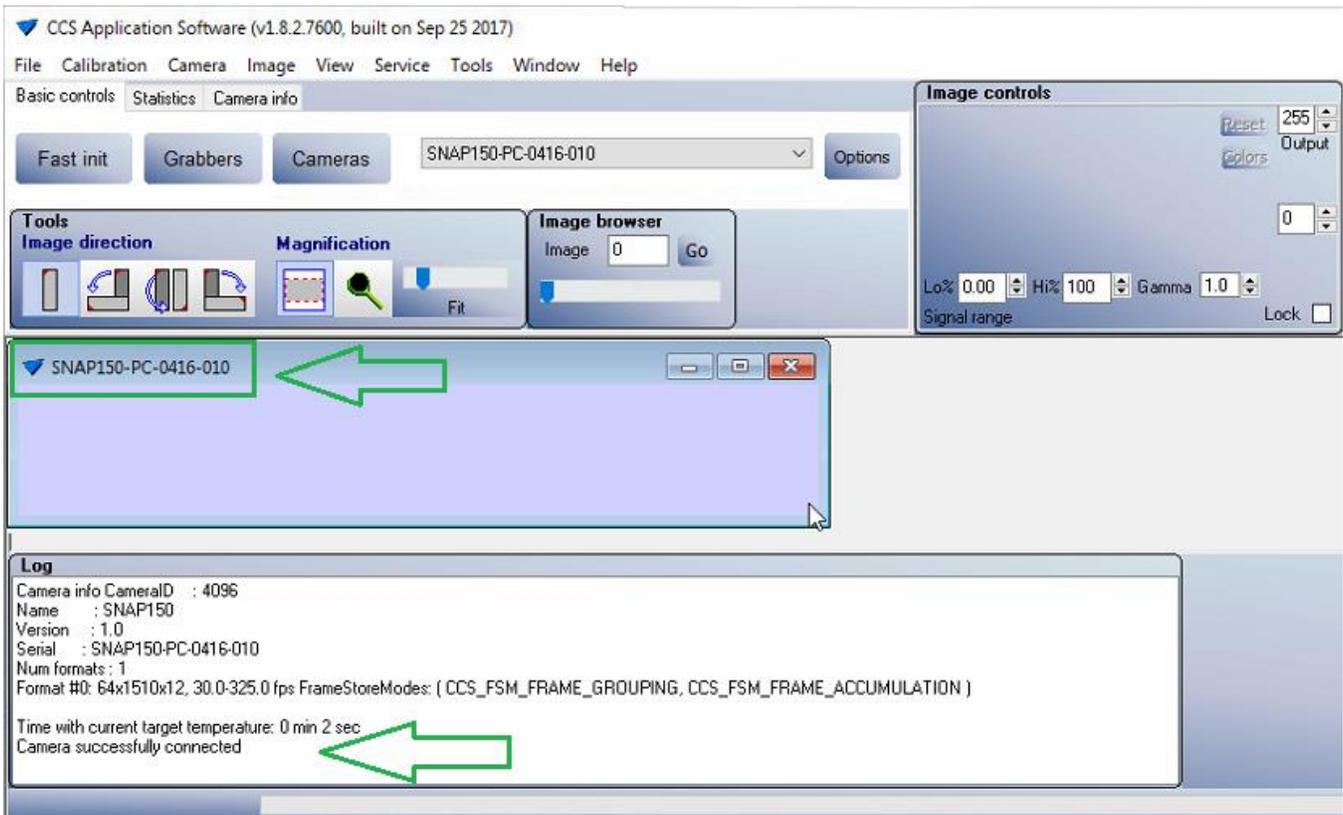
Again the real-time log will show a camera successfully connected.

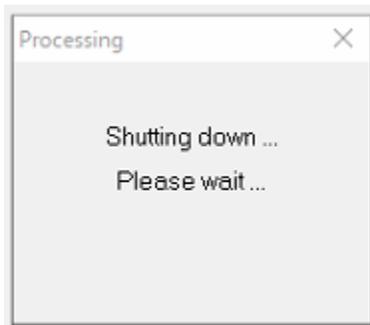
After a successful connection, close the srvtester application.

The program will stop/start the background process. Please wait.

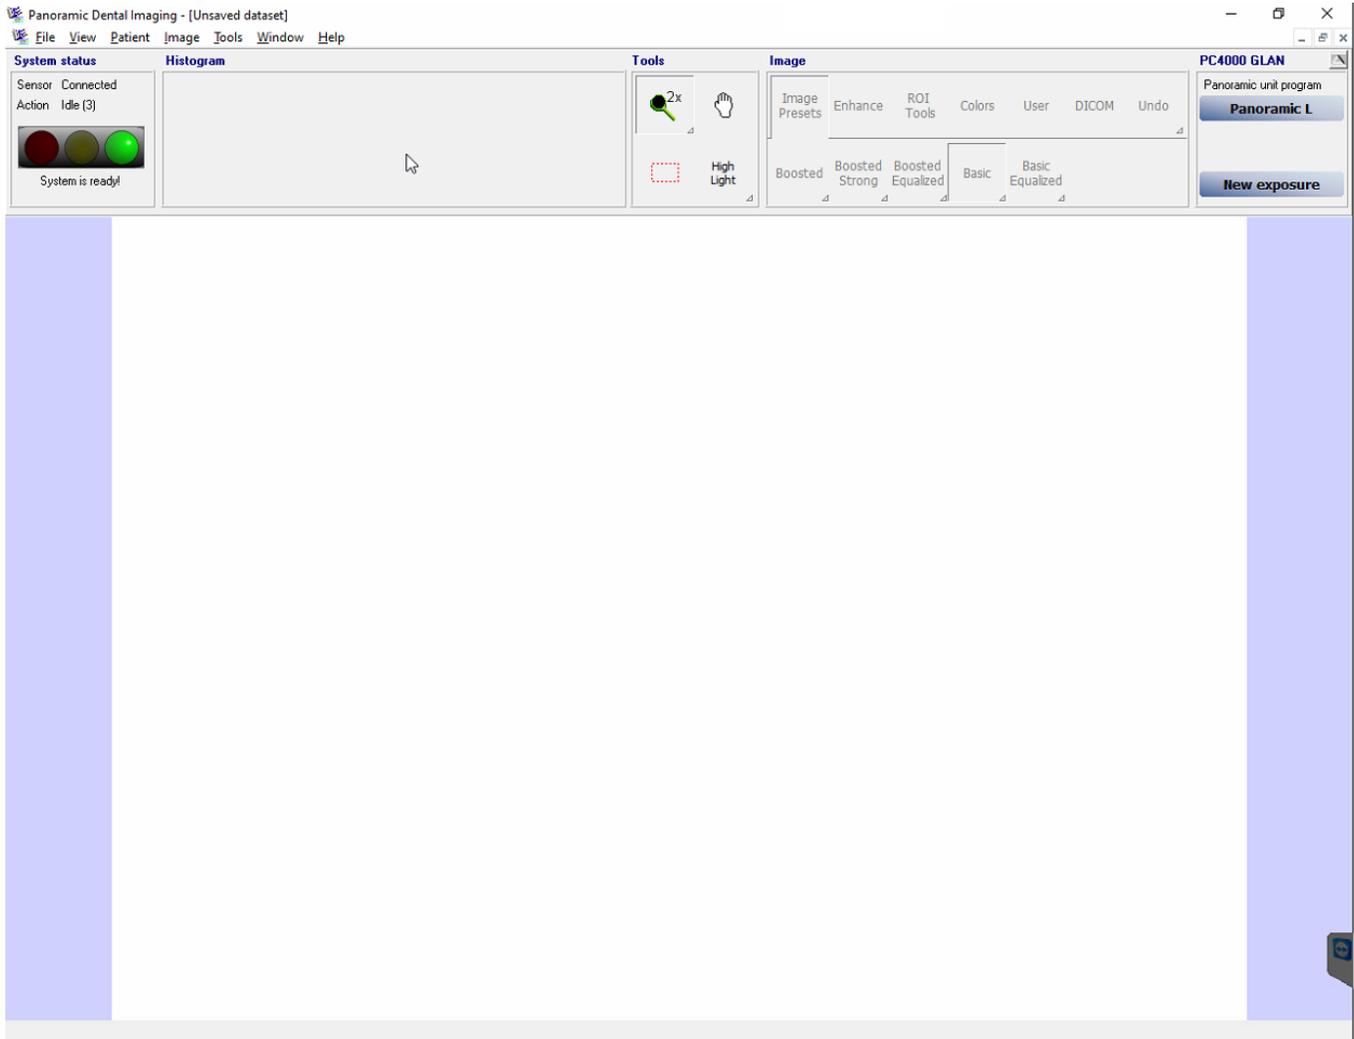
After the notice disappears, wait 2 seconds and then Open the Panoramic Dental Software from the desktop shortcut.

You should find a GREEN Connection in the top left.

If the connection was resolved using the `srvtester.exe` application, this means that the automatic connection feature within the program could not detect key functions/settings and needed to be told how to connect. This can occur if there were complications during the software installation guide, or if the grabber was not in the PC at the time the software was installed. As uncommon as this is, whenever used, it typically is on a new setup/installation of a computer.
